# Recoater crashes during powder bed fusion of metal with laser beam: simulative prediction of interference and experimental evaluation of resulting part quality

Stefan Brenner<sup>1,3</sup> · Martin Moser<sup>1,3</sup> · Lea Strauß<sup>2,3</sup> · Vesna Nedeljkovic-Groha<sup>1,3</sup> · Günther Löwisch<sup>2,3</sup>

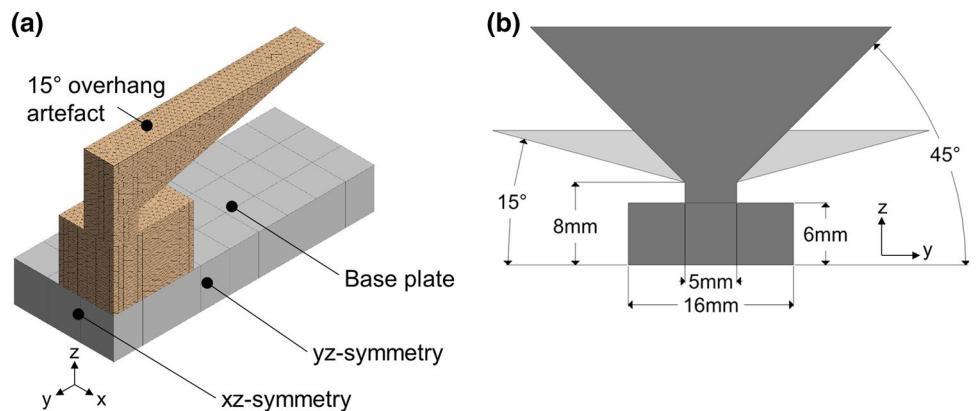
**Fig. 1** **a** Quarter-symmetry FE model and **b** critical overhang artifact dimensions

A quarter-symmetry FE model was used with the critical part dimensions, as shown in Fig. 1. By varying the overhang angle  $\alpha$ , the intensity of the super-elevation effect was studied.

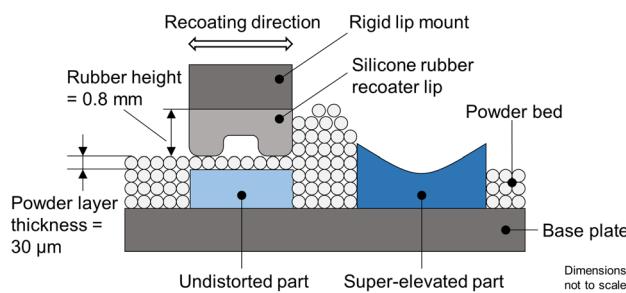
**Fig. 2** Schematic of the recoater moving toward super-elevated part edges. The interference of the super-elevated part with the rubber recoater lip is referred to as recoater crash in this study. A collision between a part and the rigid lip mount is likely to result in wear or more severe machine damage

than the nominal value [22]. The ELT is reported to be 4 to 5.5 [23] or even more than 7.5 times [24] the nominal layer thickness. Reasons for this are shrinkage effects after solidification [24], formation of spatter and denudation [23]. Considering this behavior, the overhang artifacts have a target range for z-distortion of  $0.2 \text{ mm} < z_{\text{dist}} < 0.8 \text{ mm}$ , with the lower limit  $z_{\text{min}}$  given by  $\text{ELT} \approx 0.2 \text{ mm}$  and the upper limit  $z_{\text{max}}$  given by the free rubber height of 0.8 mm (Fig. 2) to avoid collision with the rigid lip mount.

For each build job, a virgin silicone rubber recoater lip was used. The schematic in Fig. 2 shows super-elevated part edges that will likely interfere with the recoater lip.

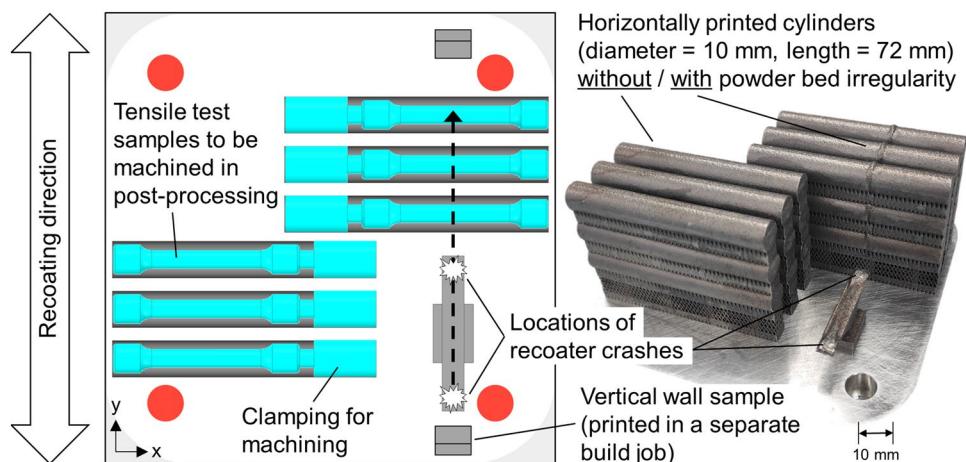
**Fig. 3** Build layout with tensile test samples and a damage-causing overhang artifact. Vertical wall samples were positioned accordingly in recoating direction, but printed in a separate build job

Samples were placed adjacent to the damage-causing artifacts aligned with the recoating direction in build layouts similar to Bartlett et al. [18] and Foster et al. [19]. Stacks of three horizontal cylinders (diameter = 10 mm; length = 72 mm) were printed to evaluate tensile test properties (see Sect. 3.3). Figure 3 shows a representative build layout used in this study. The longitudinal orientation of the artifact was aligned with the recoating direction and the dotted line arrow indicates the expected transfer of powder bed irregularities from the artifact to the adjacent samples.

The cylinders were printed at three different build heights  $h_{\text{build}}$ , with the axes at z-positions of 18.4 mm, 31.4 mm, and 44.4 mm. This ensured that the samples were positioned above the artifact and thus printed with a damaged recoater lip. Block supports were used as a connection between the cylinders and to the base plate. In a post-processing step, the cylinders were machined to standardized tensile test samples

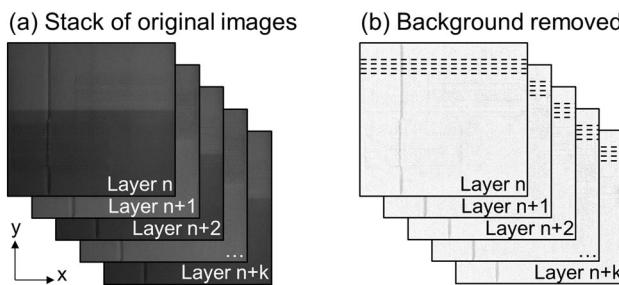
**Fig. 4** LCS image processing steps with **a** stack of original images and **b** images after background removal

The SLM 125HL machine is equipped with a Layer Control System (LCS) that takes 8-bit grayscale images after a new powder layer is spread. Therefore, for each build job, a stack of images was taken that corresponds to the number of layers. These images were analyzed to check for appearing powder bed irregularities, indicating local damages to the recoater lip. The image processing steps are shown in Fig. 4 for an exemplary stack of  $n+k$  images. Because of an uneven illumination within the build chamber (Fig. 4a), the background of the images was removed utilizing the ImageJ software (National Institutes of Health, USA) to enable meaningful grayscale value measurements. To determine the beginning of a recoater crash, the grayscale value of each pixel was measured along several parallel profiles (dashed lines in Fig. 4b) in the x-direction in each image. The average value for each column of pixels was formed. From this, local changes in the grayscale values during a build job could be recognized and interpreted as appearing powder bed irregularities.

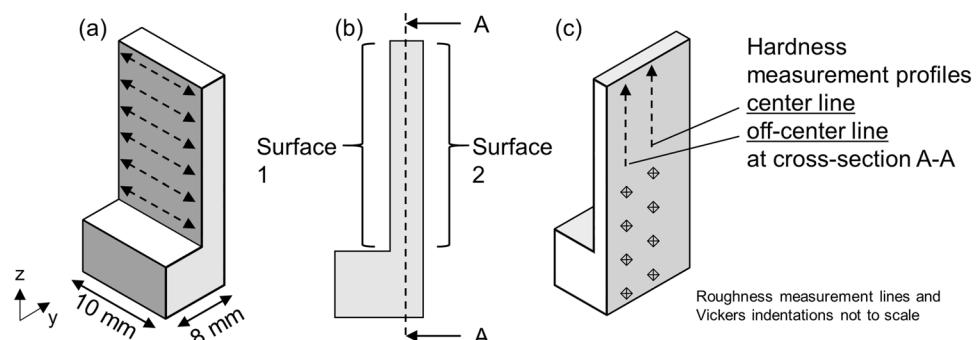
**Fig. 5** Locations of **a** roughness and **c** Vickers hardness measurements. Flatness tolerances were measured on **b** Surface 1 and Surface 2

The average roughness  $R_a$  was measured at parallel, horizontal lines with lengths of 7.5 mm on the vertical wall surfaces (Fig. 5a) with filter settings  $\lambda_s=25 \mu\text{m}$  and  $\lambda_c=2.5 \mu\text{m}$ . To compare regular and irregular powder bed conditions, areas were selected at build heights before and after the recoater crash.

Regarding the flatness tolerances, the height distance between the minimum and maximum of the topography at wall surfaces 1 and 2 (Fig. 5b) was measured in each case.

Next, the wall samples were embedded and ground. Vickers hardness  $HV0.5$  was tested on cross-sections A-A (Fig. 5b) using a hardness tester (ecoHARD XM 1280 A, AHOTEC e.K., Germany). Measurement points with a

spacing of 1 mm were placed in the z-direction long center and off-center lines (Fig. 5c).

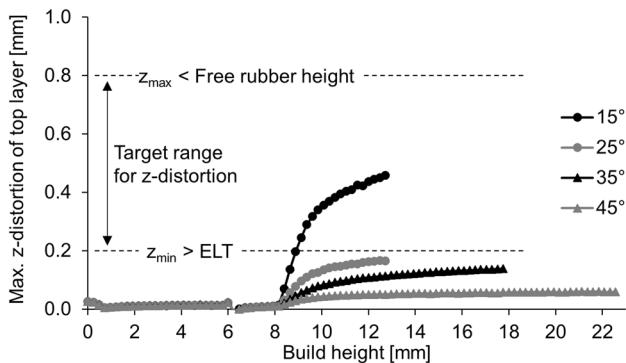
**Fig. 6** Simulation results for in-process z-distortions of artifacts with overhang angles  $\alpha$  of  $15^\circ$ ,  $25^\circ$ ,  $35^\circ$ , and  $45^\circ$ . Only the artifact with an overhang angle of  $15^\circ$  reaches the target range for z-distortion

The simulation outputs of  $z_{\text{dist}}$  for every simulated *super layer* of the overhang artifacts with  $15^\circ < \alpha < 45^\circ$  are analyzed. Figure 6 shows the curves of  $z_{\text{dist}}$  of the current top *super layer* over  $h_{\text{build}}$ . The curves only differ from  $h_{\text{build}} = 8$  mm, which is the beginning of the overhangs. The  $15^\circ$  overhang angle shows the steepest increase and crosses the  $z_{\text{min}}$  level at  $h_{\text{build}} \approx 9$  mm. It reaches the highest  $z_{\text{dist}}$  of 0.46 mm but remains below  $z_{\text{max}}$ .

The results show a clear trend toward more pronounced super-elevation at smaller overhang angles  $\alpha$ , which was also expected. Only the overhang artifact with  $\alpha = 15^\circ$  reaches the target range for  $z_{\text{dist}}$ , indicating that this variant distorts sufficiently to damage the recoater lip, but does not distort enough to cause a collision with the rigid lip mount. Therefore, the  $15^\circ$  artifact is considered suitable to fulfill the purpose of causing recoater crashes without damaging the machine. Despite known limitations in the ability of simulation models to predict recoater crashes [12] and model abstractions (see Sect. 2.1), this design is selected as the damage-causing artifact for all build jobs in this study.

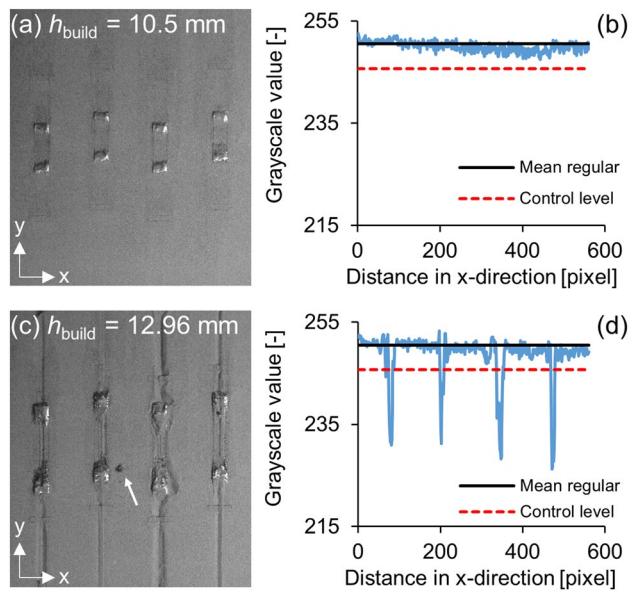
**Fig. 7** Original LCS image of build heights 10.5 mm **a** and 12.96 mm **c** with corresponding grayscale value measurements **b** and **d**. Mean regular=250.5, control level=mean– $6\sigma$ =245.7. The white arrow in **c** points to a torn-out piece of rubber from the damaged recoater lip

$h_{\text{build}} = 10.5$  mm (Fig. 7a), but no irregularities are yet present (Fig. 7b). After the super-elevated edges have interfered with the recoater lip, the further powder layers are spread with a damaged lip, resulting in irregularities in the powder bed. The occurrence of irregularities is detected by LCS in the range of  $10.8 \text{ mm} < h_{\text{build}} < 11.8$  mm with some scatter between the four artifacts. At  $h_{\text{build}} = 12.96$  mm (Fig. 7c), the irregularities are clearly visible and the grayscale measurements show downward spikes to values of about 230, which are significantly below the control level of 245.7 (Fig. 7d). The white arrow (Fig. 7c, middle) points to a torn-out piece of rubber from the damaged recoater lip.

The occurrence of super-elevations starting at  $h_{\text{build}} \approx 9$  mm corresponds well with the simulated  $z_{\text{dist}}$  exceeding the  $z_{\text{min}}$  level at about this build height. The predicted further increase in  $z_{\text{dist}}$  can also be validated by the observed powder bed irregularities and the damage to the lips. Although some notches in the lips are deeper than the free rubber height (Fig. 2), the rigid lip mount remains unscathed. This suggests that the in-process z-distortions of the artifacts are less than  $z_{\text{max}}$ . The deep notches may be caused by abruptly torn-out rubber pieces and not by layer-by-layer wear. During the build job, pieces of rubber were found in the LCS images of several layers, as exemplified

in Fig. 7c. The protruding snippets may have been flexible enough to bend but not be torn out when they passed the super-elevated edges during the recoater movement.

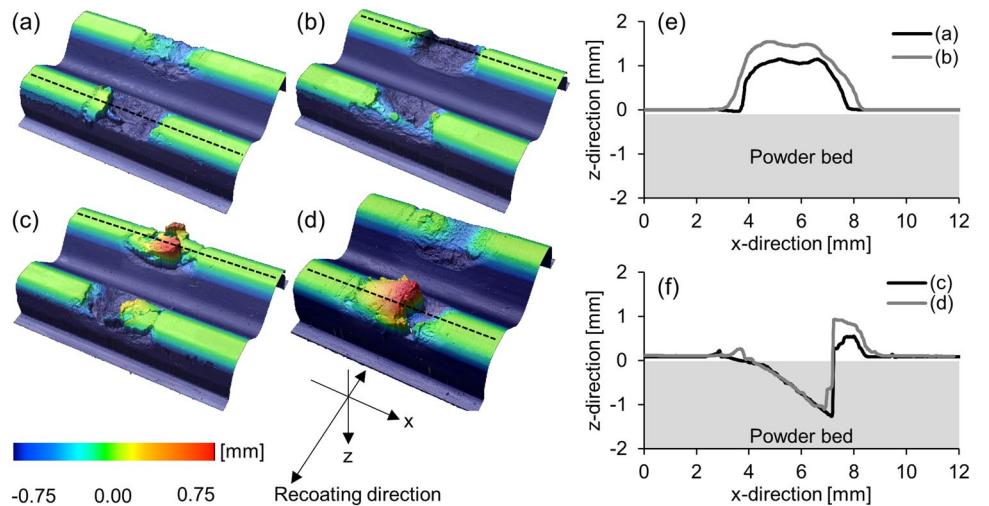
**Fig. 8** Scanned contour of recoater lips after crash with notch-type damage **a**, **b** and snippet-type damage **c**, **d**. Height profile of notch-type damage **e** and snippet-type damage **f**. Dashed lines in **a-d** show the profile lines of **e** and **f**

After build job completion, the recoater lips exhibit two types of damage. First, there are notches in the lips (Fig. 8a,b) that are up to 1.5 mm deep and about 4 mm wide (Fig. 8e). Second, there are rubber snippets (Fig. 8c, d) that protrude downward from the lips by up to 1 mm (Fig. 8f).

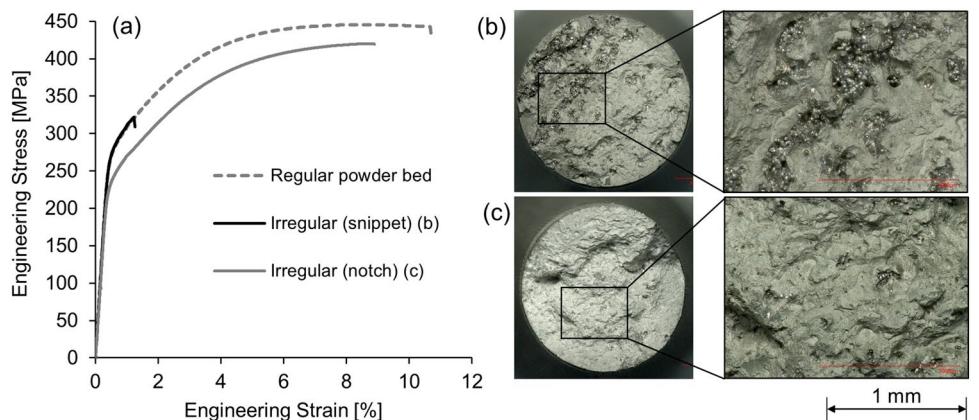
**Fig. 9** **a** Engineering stress-strain curves for samples with regular and irregular powder bed conditions and fracture surfaces for **b** snippet-type damage and **c** notch-type damage. For better readability, only one representative stress-strain curve is shown each

The samples show different behavior depending on the type of damage to the recoater lip. One representative stress-strain curve is plotted in Fig. 9a each for samples printed with a regular powder bed as reference (dotted line), with irregularities from snippet-type damages (black line) and with notch-type damages (gray line). The samples with snippet-type damages perfectly follow the reference curves, but break at low  $\epsilon_{\text{break}}$  of 1% to 3%, depending on their  $h_{\text{build}}$ . Large areas of unmelted powder particles are found on the fracture surfaces (Fig. 9b). The samples

with notch-type damages yield earlier, however, show plastic deformation up to an  $\epsilon_{\text{break}}$  of 8.8% at  $h_{\text{build}} = 18.4$  mm. Only a few unmelted particles are observed on the fracture surfaces (Fig. 9c). From the build job with notch-type damages, only samples from  $h_{\text{build}} = 18.4$  mm are available.

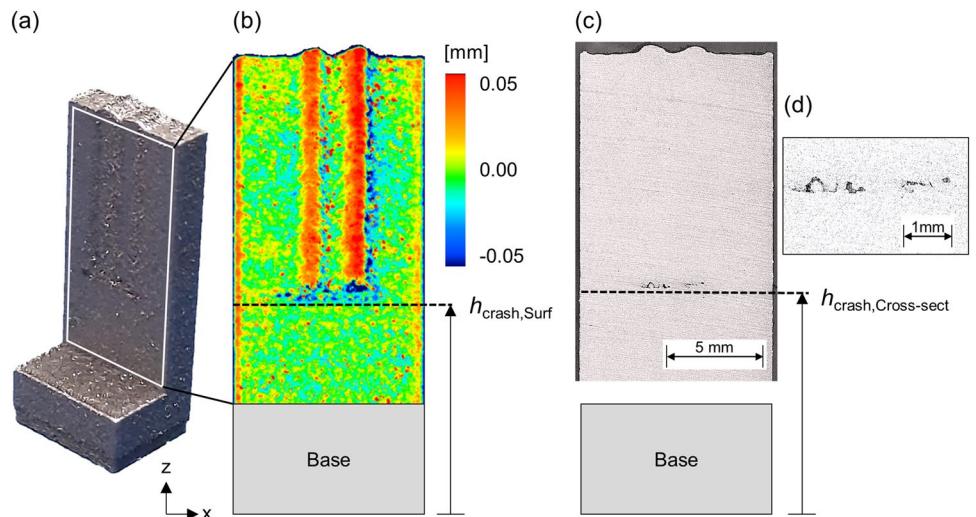
**Fig. 10** **a** As-built vertical wall sample with surface topography **b**, Cross-section of embedded and ground sample **c** with detail of defect **d**

The defects in the sample surfaces are clearly visible (Fig. 10a) and the samples show distinct build heights  $h_{\text{crash,Surf}}$  at which the recoater lips are damaged (Fig. 10b). Large LoF defects are found in the cross-sections (Fig. 10c, d) at  $h_{\text{crash,Cross-sect}}$ . The effects are independent of the damage type of the recoater lip.
