Influence and handling of process interruptions in PBF-LB of AlSi10Mg

Abstract

Keywords Powder bed fusion of metal with laser beam (PBF-LB/M) · AlSi10Mg · Process interruption · Additive manufacturing (AM) · Mechanical properties

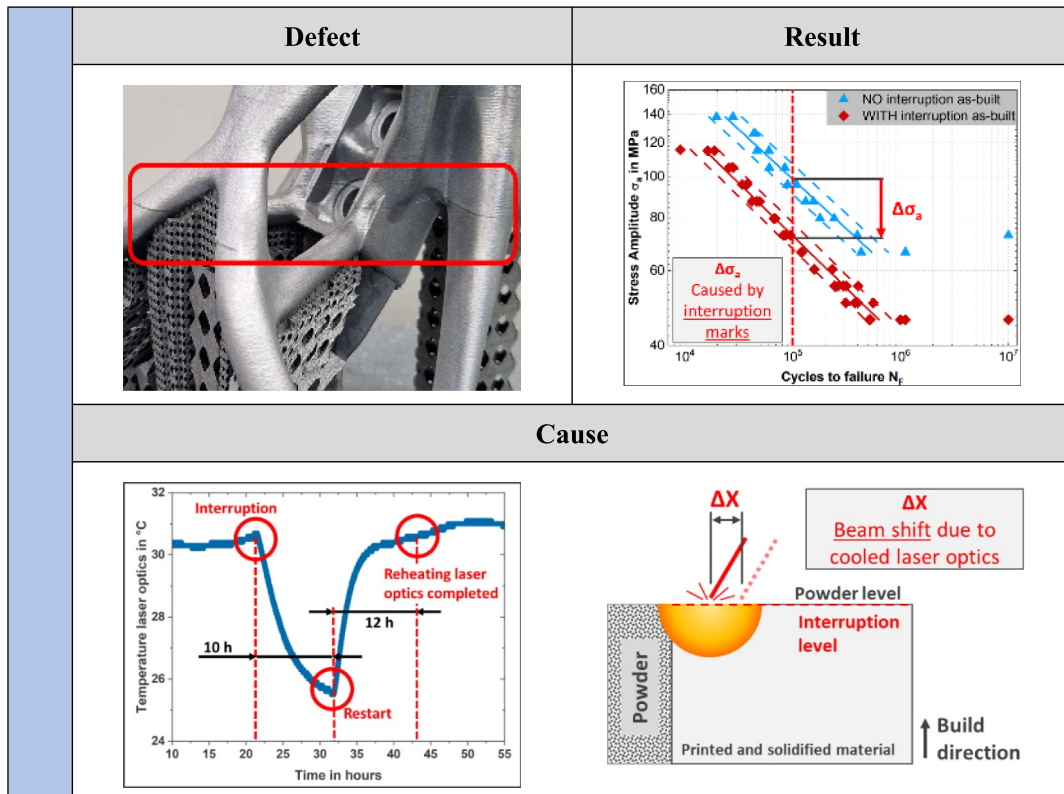
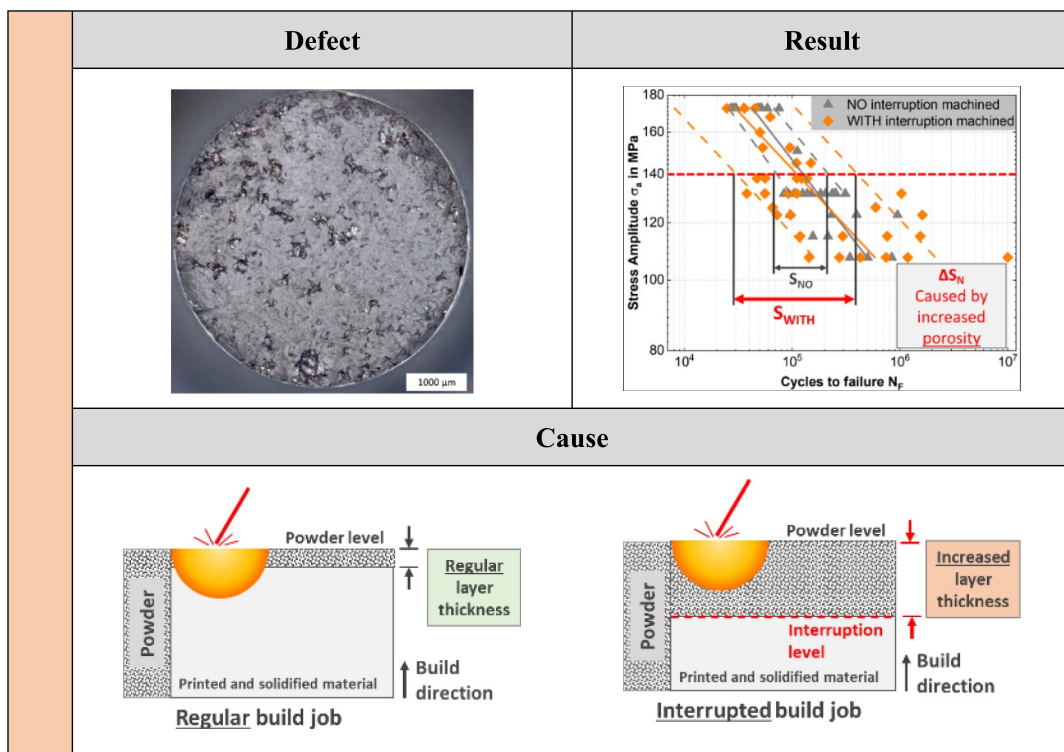
a)

b)

Fig. 2 Critical defects due to an interruption in PBF-LB/M with their results and causes [12]. **a** Interruption marks result in a reduction in fatigue strength due to their notch effect. Their formation is caused by a positioning error of the laser spot as a consequence of the cool-down of the laser optics. **b** More porosity leads to a higher scattering of fatigue life. The reason for this is an increased layer thickness due to the cooling and shrinking of the components

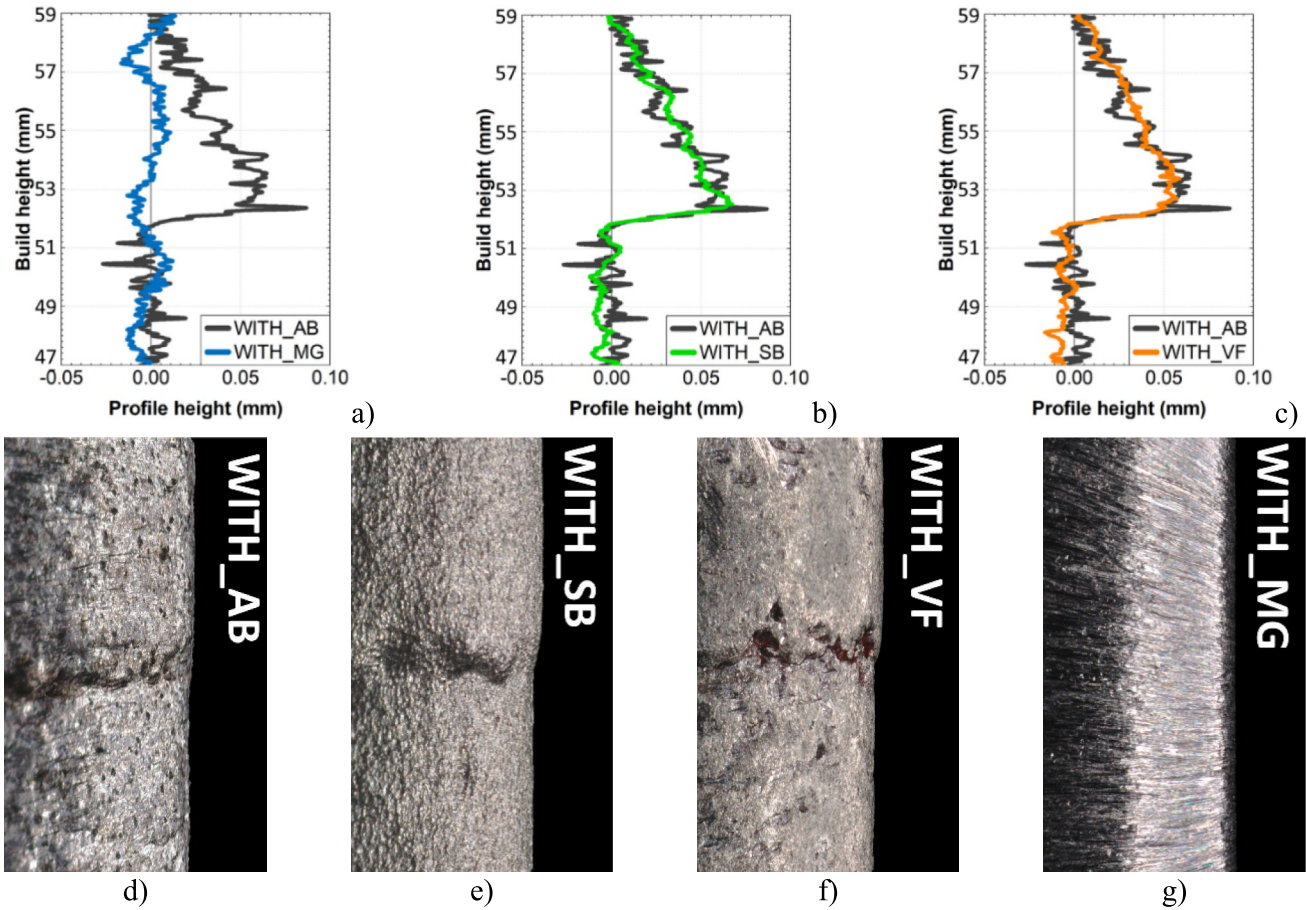
Fig. 5 Exemplary profile curves and images of the interruption marks in the processing states as-built (WITH_AB), manually ground (WITH_MG), blasted (WITH_SB), and vibratory finished (WITH_VF)

Profile curves and images of the interruption marks for each machining condition are shown in Fig. 5. As expected, manual grinding is the only method capable of completely removing the mark (Fig. 5a, g). In the AB state, a rough profile and adhering powder particles are visible (Fig. 5a, d). Blasting and vibratory finishing remove these adhesions and smooth the mark (Fig. 5b, c, e, f). However, this only reduces the size of the mark by $20 \mu\text{m}$ (Table 3). The smoother profile and the overall lower surface roughness indicate an increased fatigue strength. The images show a significant difference between the blasted (WITH_SB) and the vibratory ground samples (WITH_VF) (Fig. 5e, f). The WITH_SB samples clearly show the dimples that are characteristic of this method, even in the fine corners of the mark. This shows that the small glass beads (grain size $100\text{--}200 \mu\text{m}$) are able to reach even the small corners of the mark. In comparison, the mark of the vibratory ground samples (WITH_VF) appears much more rugged. This means that the 10 mm abrasive media cannot penetrate as far into the contour of the mark as the much finer glass beads. This suggests a significant difference in the fatigue life of blasted and vibratory finished samples. Furthermore, when analyzing the profile of the as-built samples, it is noticeable that the offset of the marks is not permanent, but slowly disappears with increasing build height. As described by Moser et al. [12], this is probably due to the slow reheating of the laser optics during the course of the build job and the associated reduction in the positioning error of the laser spot as shown in Fig. 2a. The preferred direction of the interruption marks mentioned by Moser et al., which correlates with the direction of the inert gas flow, was also observed in this study.

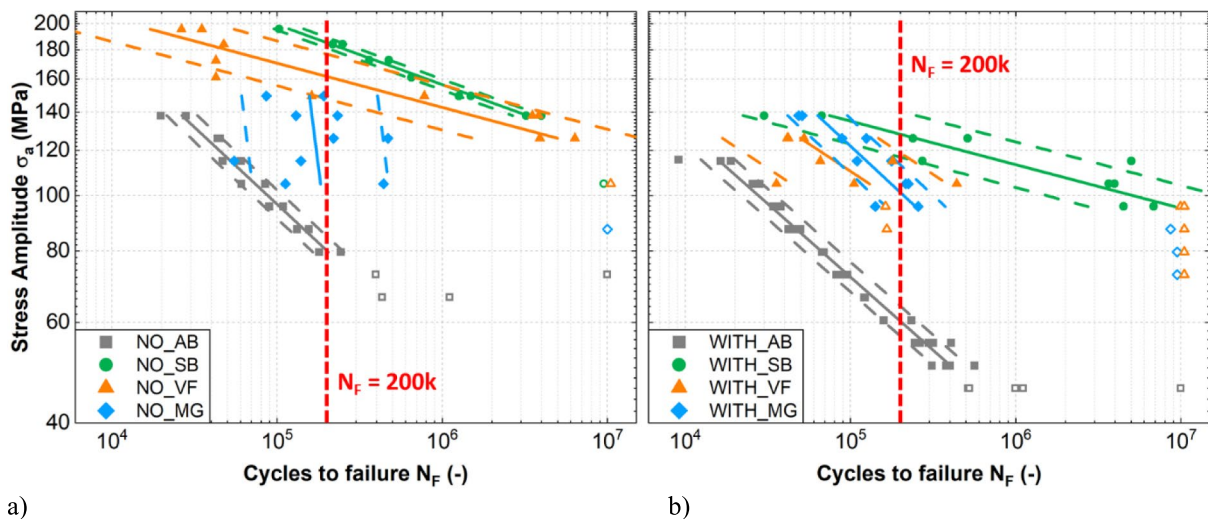
Fig. 7 S–N diagram for specimens produced without (a) and with an interruption (b) in the machining conditions as-built (AB), blasted (SB), vibratory finished (VF), and manually ground (MG), including a crack probability of 10% and 90% (dashed lines) and 50% (solid

lines). The dashed red lines indicate a fatigue life of $N_F = 200k$. Open symbols represent load levels with runouts which were not considered for the statistical analysis

Figure 7 shows the S–N diagram, where the stress amplitude σ_a is plotted against the number of cycles to failure N_F on a double logarithmic scale. The diagram includes lines representing crack probabilities of 10%, 50% and 90%. Samples

Figure 7a compares the fatigue properties of the specimens produced without an interruption (NO). The regularly printed samples in the as-built state (NO_AB) serve as the benchmark. As the previous results already suggested, all post-processing methods have a positive effect on fatigue life. Blasting (SB) more than doubles the theoretically endurable stress amplitude for $N_F = 200k$ load cycles from $\sigma_{a,200k} = 80$ MPa to 185 MPa. In addition, the S–N curve has a less steep gradient ($k_{AB} = 3.7$, $k_{SB} = 9.5$), which also indicates a higher fatigue strength. This is the result of the lower surface roughness and the existing residual compressive stresses. A smaller increase can be seen after vibratory finishing (VF). Here, the bearable load amplitude increases

Figure 7b shows the samples printed with an interruption of 10 h. In case of the as-built specimens, the fatigue strength decreases by 25% to $\sigma_{a,200k} = 60$ MPa due to the notch effect of the marks. The scatter of the values and the gradient of the S–N curve are similar for both sample types. Fatigue strength is significantly influenced by near-surface defects and inhomogeneities such as roughness, pores or geometric defects [13, 35–38]. The mark represents such a defect with a size of more than 100 μm and has a negative effect on the fatigue properties. Although the values of the not interrupted specimens are not achieved, the fatigue strength is significantly improved by the tested post-processing methods. Despite the fact that neither vibratory finishing nor blasting was able to remove the mark, the load amplitude that can be applied increased strongly by 62% after vibratory finishing and even 113% after blasting. The interruption marks were completely removed only by manual grinding. For this reason, it was expected that this method would generate the best results. However, the strength of $\sigma_{a,200k} = 101$ MPa is only slightly higher than that of the vibratory finished samples (97 MPa) and much lower compared to the blasted samples (128 MPa).

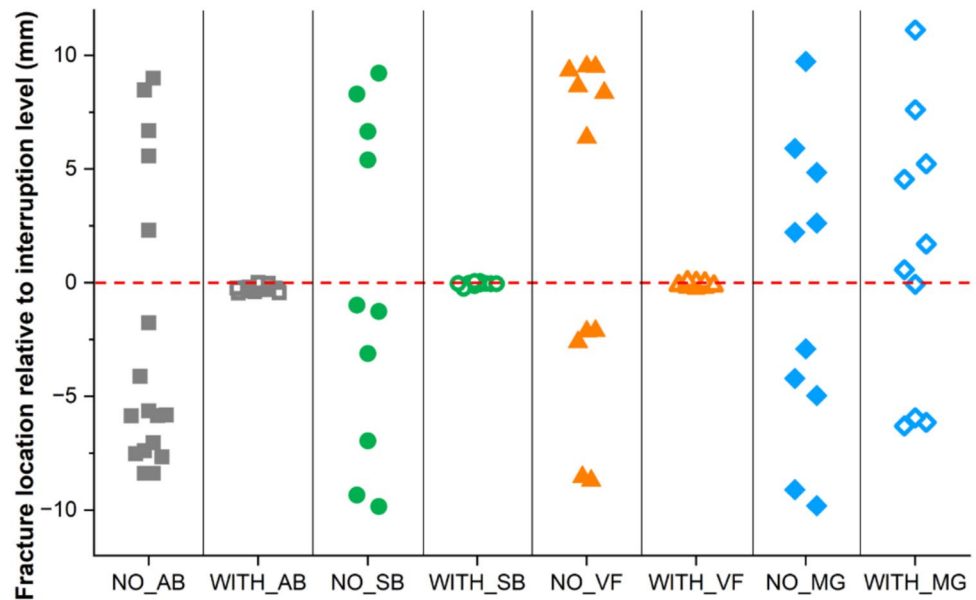
Fig. 8 Fracture locations relative to the interruption level (dashed red line) for the investigated machining conditions

Figures 8 and 9 show the fracture locations of the fatigue specimens in relation to the interruption level, indicated by the red dashed line in Fig. 8 and markings in Fig. 9. Since the fracture behavior is identical for the three processing states AB, SB and VF, only the AB specimens are shown in Fig. 9 as a representative example. The regularly printed samples (NO) show a random and wide distribution of the fracture location. In contrast, for interrupted specimens (WITH), the as-built, the blasted as well as the vibratory finished specimens fail exclusively near the interruption level. Only the manually ground samples do not exhibit a distinct fracture pattern. Here, the influence of the individual post-processing method was evident. With blasting, a stationary condition is likely to be established after a sufficient processing time, which does not change significantly even after a longer processing time and which is independent of the operator. A completely different situation can be seen after manual grinding. Depending on the operator, the material removal and the uniformity of the reworked surface varies greatly. This is also reflected in the fracture behavior of the specimens. The random distribution of the fracture location suggests that the most critical effect of an interruption has been eliminated by the removal of the interruption marks. In addition to the marks, an increased porosity in the interlayer is another critical defect resulting from an interruption of a PBF-LB/M process as shown in **Error! Reference source not found.** b. For this reason, it was expected that the interruption level would remain the weak point of the manually ground samples and that a high proportion will still fail within this area. However, the random distribution of the fracture suggests that other effects appear to be more critical than the increased porosity in the interruption level. The uneven reworking creates local differences in roughness, residual stresses and, in some cases, significant differences in diameter within the gage section. In addition, defects close to the surface with random size and distribution are exposed, concealing the local effects of increased porosity in the interruption level. This effect is even greater for rotating bending test, since the bending stress increases toward the surface.

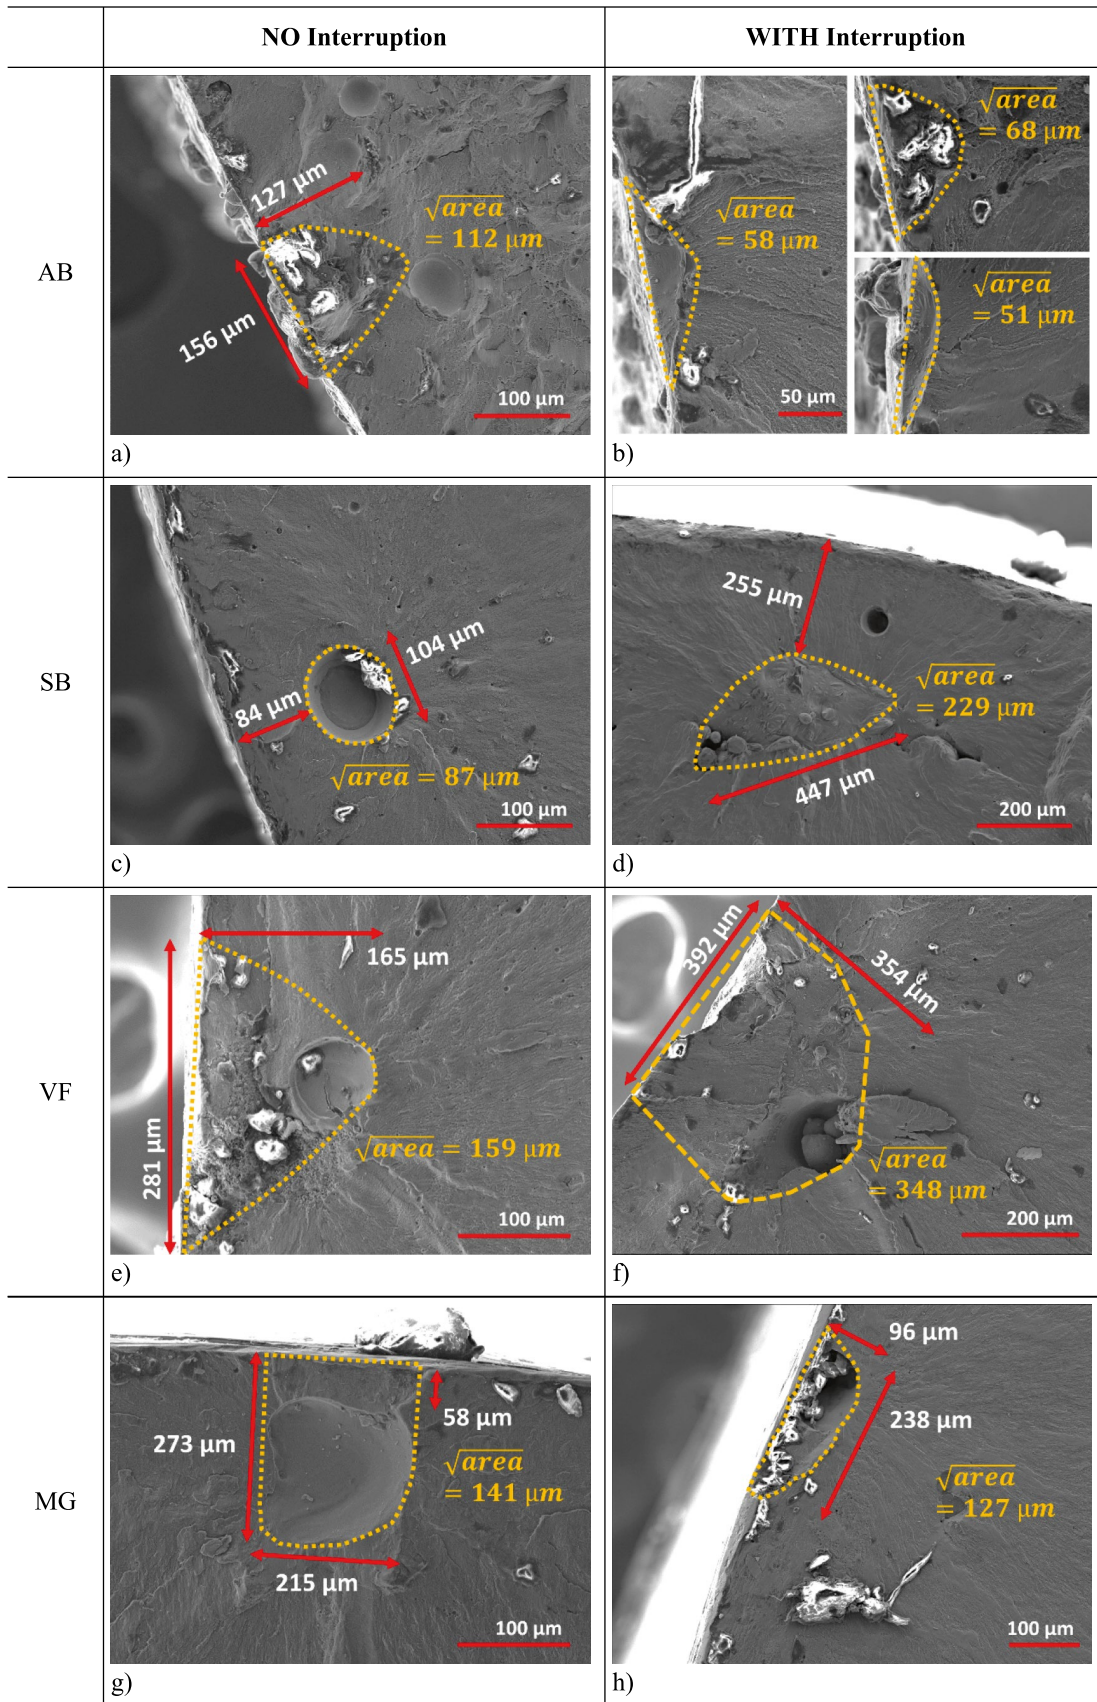
Fig. 10 Exemplary locations, dimensions, and $\sqrt{\text{area}}$ according to Murakami [29] of fracture-causing defects

All regular as-built samples failed at single inhomogeneities directly at the surface (Fig. 10a). Numerous studies have proven that crack growth always starts from a defect at the surface due to the higher residual stresses [13, 30, 39, 40]. In contrast, several smaller defects are present on the surface of the interrupted as-built specimens, indicating an overall defective area, as also shown by Mahtabi et al. [11]. Figure 10b shows three exemplary defects that are close to each other. The many small defects merge and lead to premature failure of the samples. In general, the fracture surfaces of the interrupted samples show more and larger lack of fusion pores. These are attributed to the increased layer thickness as a result of an unsuitable restart procedure when continuing the build job.

Regardless of whether there was an interruption or not, the fracture in the blasted samples always starts from an inhomogeneity below the surface (Fig. 10c and d). However, other studies have found that even in the presence of

Despite the existing residual compressive stresses, the NO_VF samples primarily fail at a defect directly on the surface (Fig. 10e). These defects are probably the craters shown in Fig. 4. Since the roughness after vibratory finishing is quite low, these profile defects are now the most critical. For WITH_VF samples, on the other hand, the crack starts at the interruption mark and extends to defects nearby

(Fig. 10f). Unlike blasting, where the fine particles can even reach the small edges and corners in the interruption marks, the abrasive media for vibratory finishing consist of triangles with approx. 10 mm in size. These large particles are unable to access the bottom of the surface craters as well as the small corners of the marks. This implies that the roughness and residual stress values in these areas might be similar to those of an as-built surface.

In case of the manually ground samples, the crack originates from defects close to the surface, which were apparently exposed during post-processing (Fig. 10g and h). This exposure of near-surface defects might provide a further explanation for the large scattering of the samples as the presence, size and location of these defects are purely coincidental.

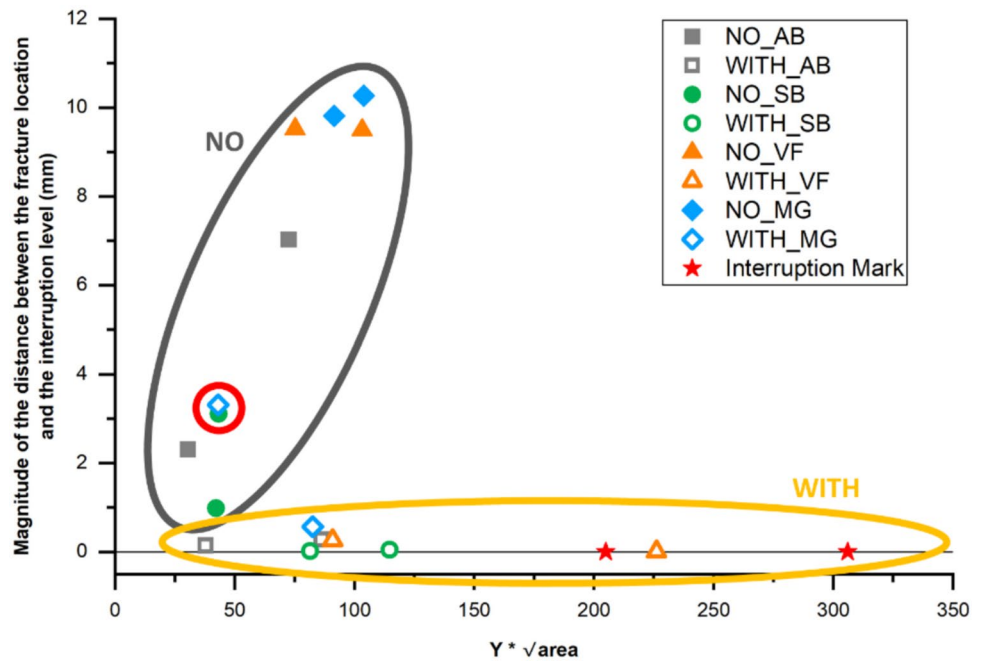
Fig. 12 Distance between the fracture location and the interruption level as a function of the product of the defect size $\sqrt{\text{area}}$ and the factor Y (0.65 for surface defects; 0.5 for defects in the volume)

Figure 12 illustrates the distance between the fracture location and the interruption level in relation to the product of the defect size $\sqrt{\text{area}}$ and the shape factor Y presented in Eq. 1. To be able to estimate the defect size range for each type, the crack-inducing defects of the samples with the lowest and the highest achieved fatigue life were measured. However, this does not mean that there are no samples with smaller or larger defects. The first noticeable aspect is the cluster formation. As can also be seen in Fig. 8, the fracture location of the regularly manufactured samples (NO) varies greatly, while the variants manufactured with an interruption (WITH) fail almost exclusively in the area near the interruption. Only one of the WITH_MG samples does not follow this pattern (highlighted by red circle). This might

be due to the non-uniformity of the specimens. It can also be seen that the range of the defect sizes is significantly larger for the WITH samples than for the NO samples. This is probably due to the negative effect of the mark and the increased porosity in the interruption level. Furthermore, the WITH_AB samples show several smaller defects as shown in Fig. 10b. This makes it difficult to identify the most critical defect here. For comparison, the defect size of the interruption mark is shown as well. As this is a defect directly on the surface, a Y of 0.65 was used. As shown earlier, the defect is significantly larger than the usual defects in regularly printed specimens. The mark is expected to influence not only the position but also the size of the crack initiating defect. Currently, their interaction is not well understood and cannot be considered in the evaluations (Fig. 12).
